MONTHLY REPORT OF ACTIVITIES

March 31, 1971

THE INJECTION AREA

Abstract: This report summarizes the activities of the National Accelerator Laboratory in March, 1971.

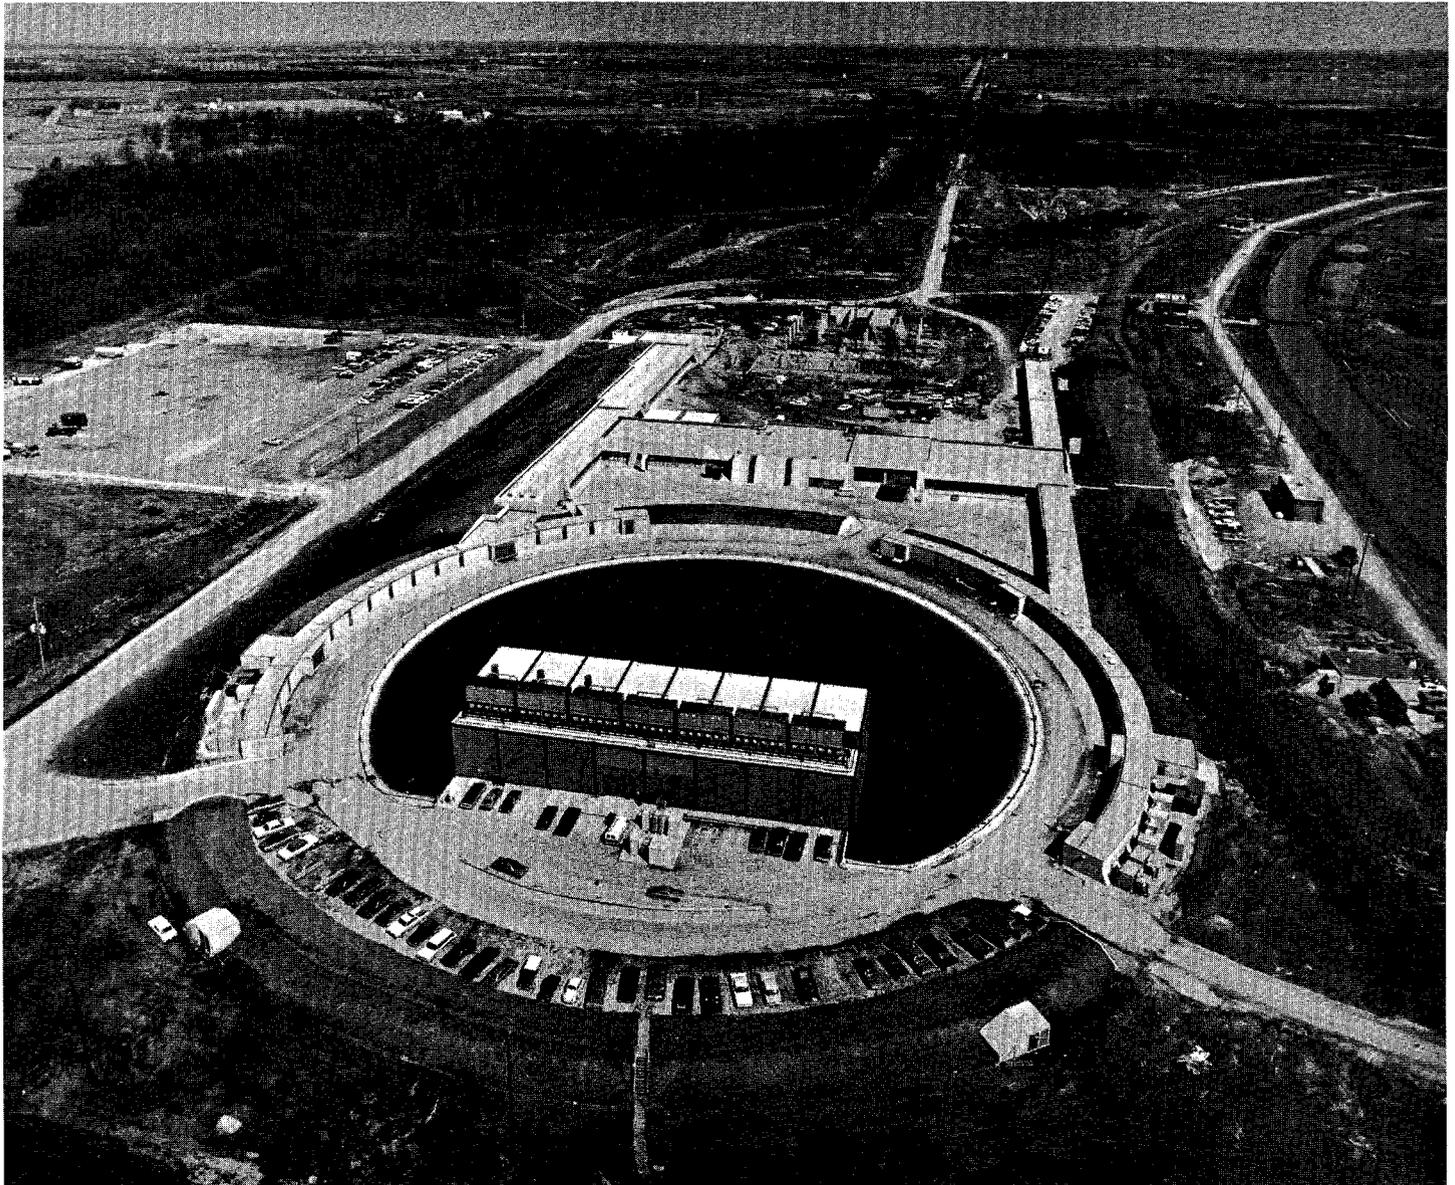
THE COVER: An aerial photograph of the Injection Area. The view looks northeast. The Main Ring is at the right, with cooling ponds, the Ring Road, service buildings, vehicle access, and the covered ring all visible. The Booster and Utility Plant are in the foreground, the Transfer Gallery, Cross Gallery, and Linac Building beyond, with the construction of the Central Laboratory enclosed in the "U". At the upper right, the Industrial Buildings can be seen. (Photo by Tony Frelø of NAL.)

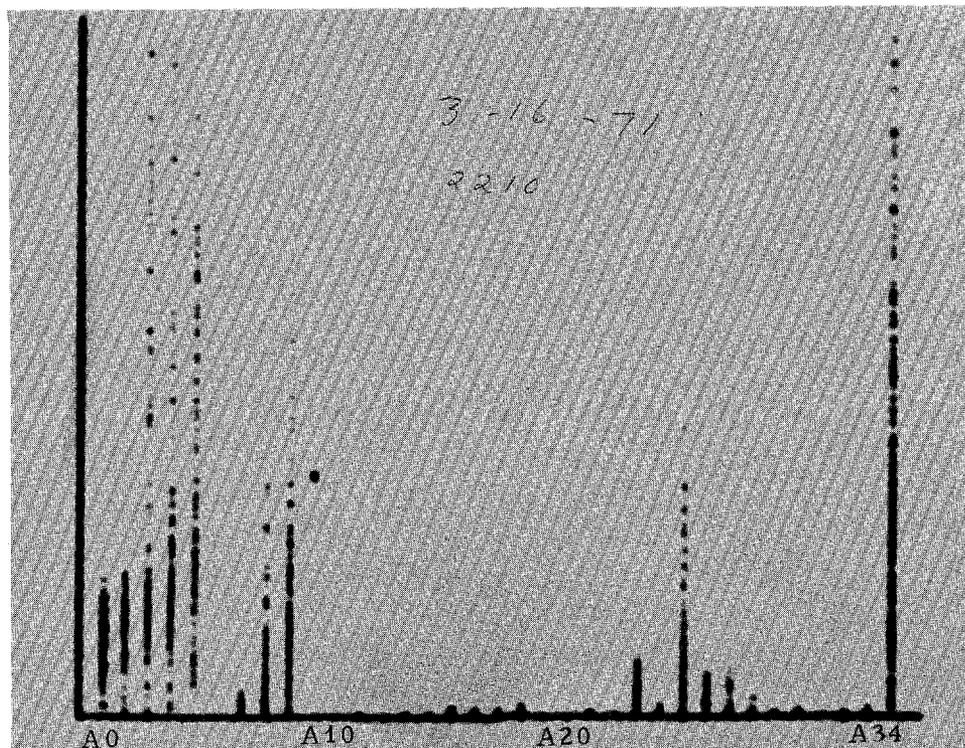
Fig. 1. Radiation monitor signals along Sector A. The vertical scale is arbitrary; we have labelled the horizontal scale with station markers, which are 100 feet apart.

1. Injection Studies. Beam was successfully brought to the end of Sector A (one-sixth of the ring) at 5:40 a. m. on March 17. A current of 1 milliampere of 1-GeV beam was injected and approximately one-fourth of this was detected in a Faraday cup at Station B0, approximately 3,400 feet from injection. A number of correction magnets were exercised during this operation, in addition to the main magnet power supply. Figure 1 shows the signals from radiation monitors along Sector A.

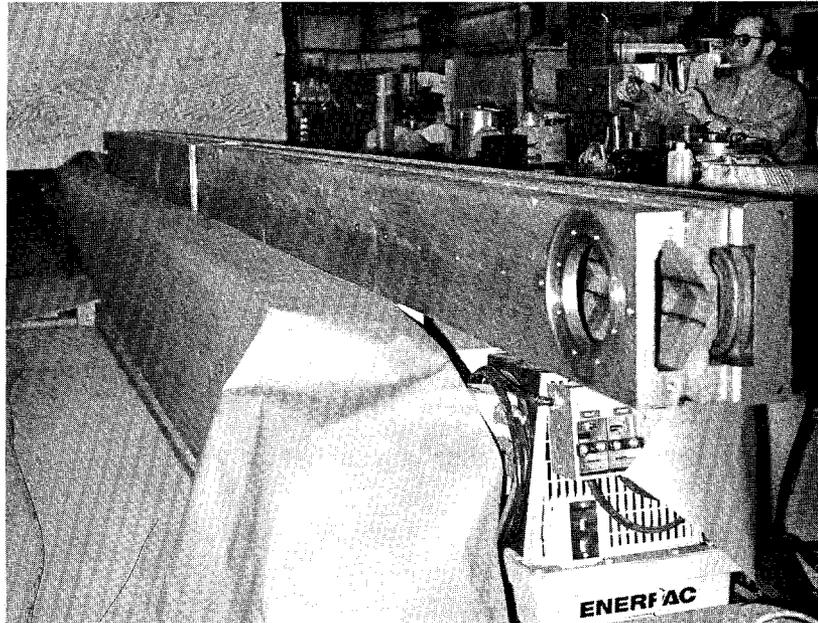
Fig. 2. A Lambertson septum magnet before installation of its stainless-steel vacuum skin.

1. 8-GeV Transfer. The Booster extraction and Main-Ring injection systems were tested during the March operation. The tests indicated that the extraction efficiency is very close to 100%.
2. 500-GeV Extraction. The two Lambertson septum magnets used to pitch the beam up vertically have been assembled. Figures 2 and 3 show one of these magnets. Several other types of magnets for the extraction system have also been completed. The electrostatic wire septum has been completed and is being installed in the Transfer Hall.
3. Main-Ring Beam Dump. The 500-GeV beam dump shell has been set in position in the external proton beam line and concrete is being placed. Figure 4 shows this shell in its final location.

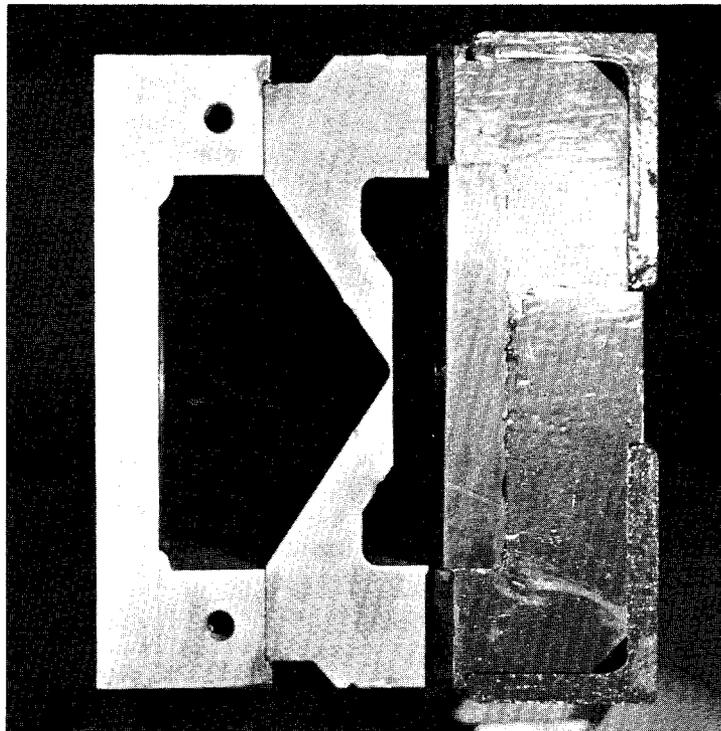
Fig. 3. Close-up of a Lambertson septum. The Main-Ring beam passes through the triangular aperture; the extracted beam passes through the 5/8-inch gap on the other side of the iron septum.

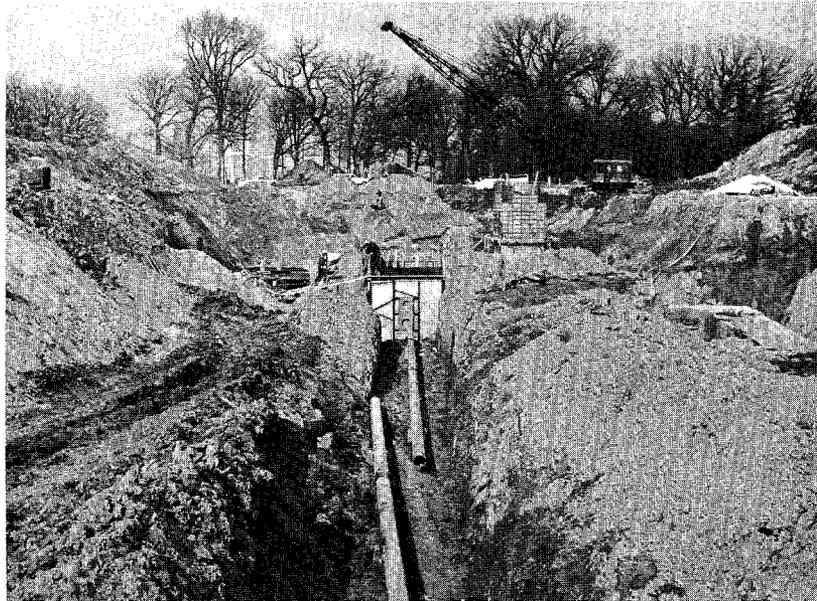
Fig. 4. Shell of the Main-Ring beam dump in place. This view is looking from the accelerator; the substation and power line can be seen at upper left. Beam pipe is being installed in the foreground and an access tunnel can be seen to the right.

3. Proton Beam Line. As we saw in Fig. 4, the beam-dump shell is in place. Forming work on the beam pipe and access tunnels has now moved north of the temporary road, as shown in Fig. 9. The entire contract is 76% complete.

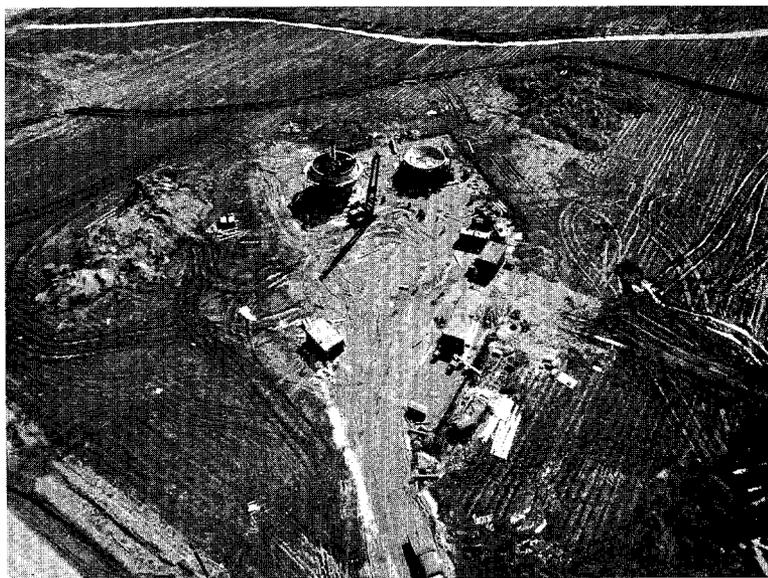
Fig. 5. Progress on the 15-foot bubble chamber as seen from the air.

Figure 5 is an aerial view of the 15-foot bubble-chamber site. The mating surfaces of the vacuum tank are being machined in the field.

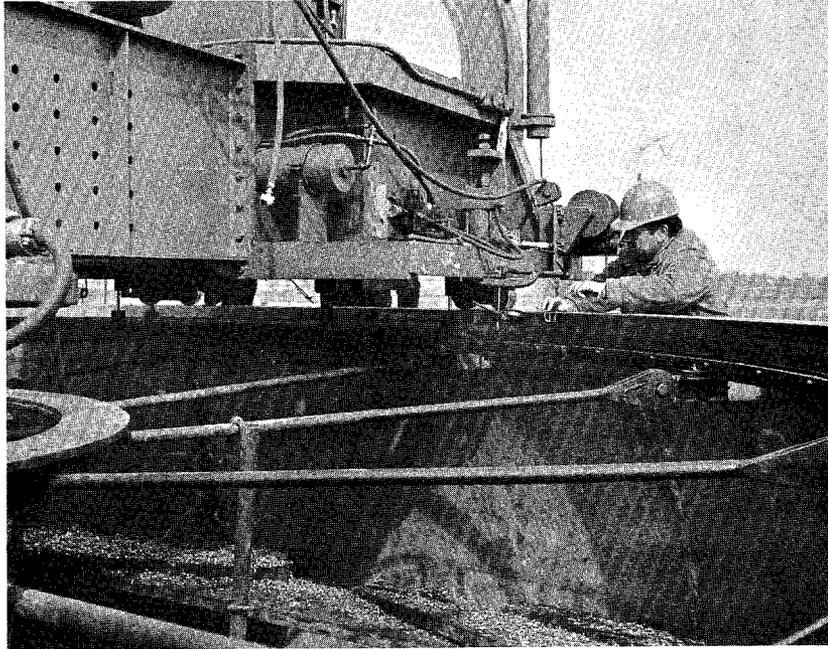
Fig. 6. Field machining on the vacuum tank of the 15-foot bubble chamber.

Figure 6 is a closer view of this work.

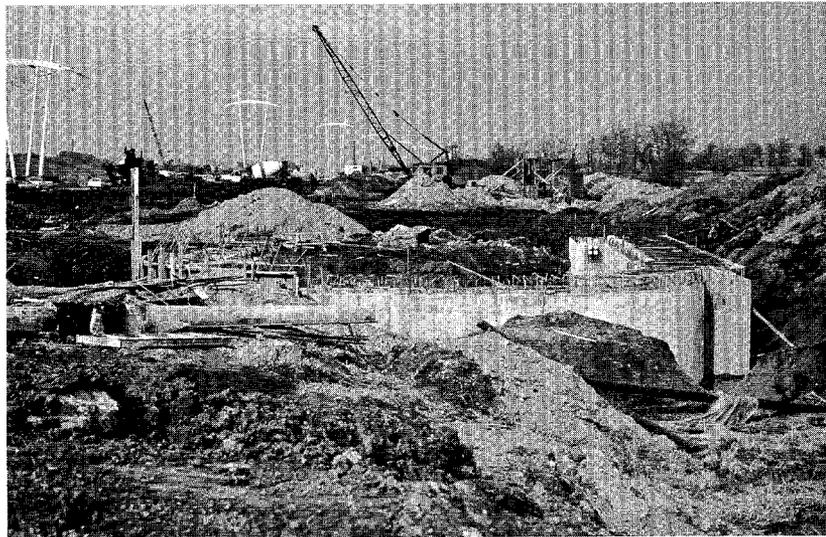
Fig. 7. Work on the Neutrino Laboratory. The curved access tunnel is an entrance to the target area. This photograph was taken looking north from Road B.

1. Neutrino Laboratory. Work on the first phase, the target area, is 20% complete. In Fig. 7, we can see structural work on this area. Approximately

60 feet of wall has been built and the railroad track started. In the second phase, out by the bubble chamber, all caisson work has been completed.

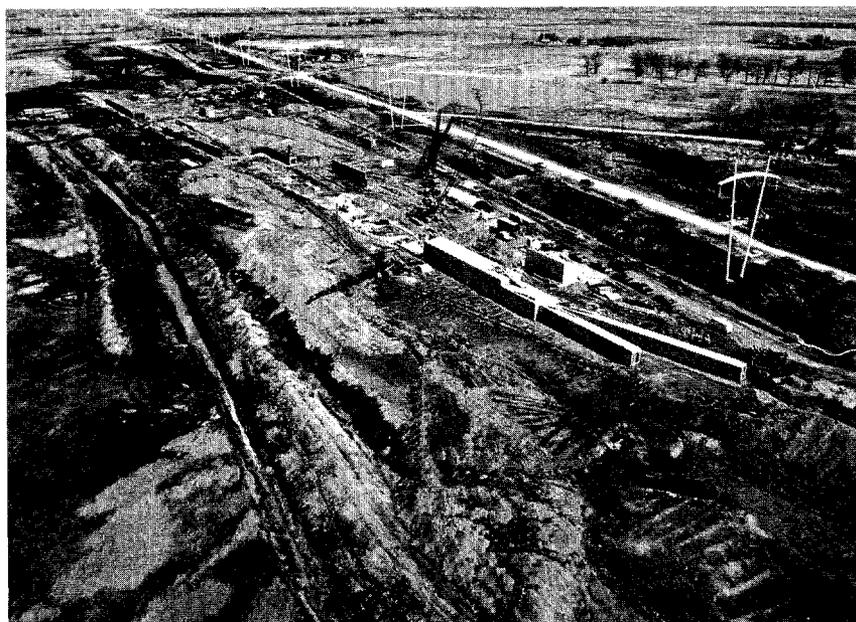
Fig. 8. An aerial view of the Meson Laboratory. The target will be just beyond the Y-shaped tunnel at the right; secondary-beam line construction can also be seen.

2. Meson Laboratory. Work on the first phase, the target area, is 37% complete. As we can see in Fig. 8, there is considerable structural work

completed on what is called the "front-end enclosure," just upstream of the target. In the second phase, which carries the work from the target area to the detector building, slabs for several of the secondary-beam lines are being placed. This contract is 28% complete.

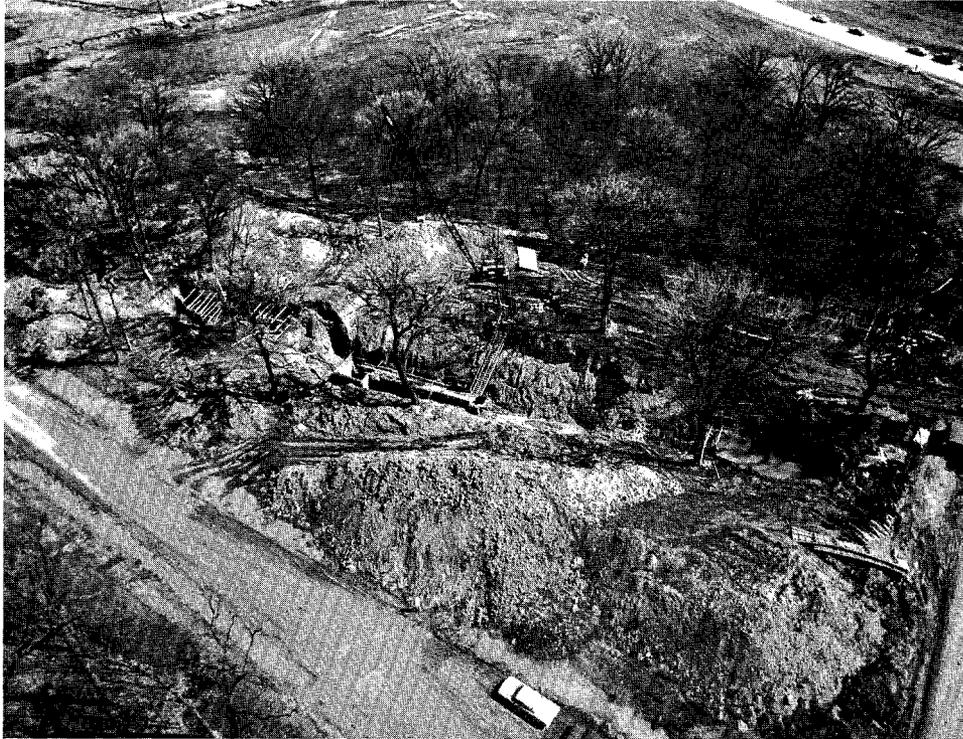
Fig. 9. The Proton Beam Line. Road A (parallel to the beam line) is in the foreground. Road B, which crosses Road A at the Substation, is at top left, and Road D, the "Village Expressway," is at top right. The road at the extreme right is the temporary bypass joining Roads D and A. The main-ring beam dump, shown in Fig. 4, is just to the right, or upstream. One can also see the care being taken to avoid damage to trees.

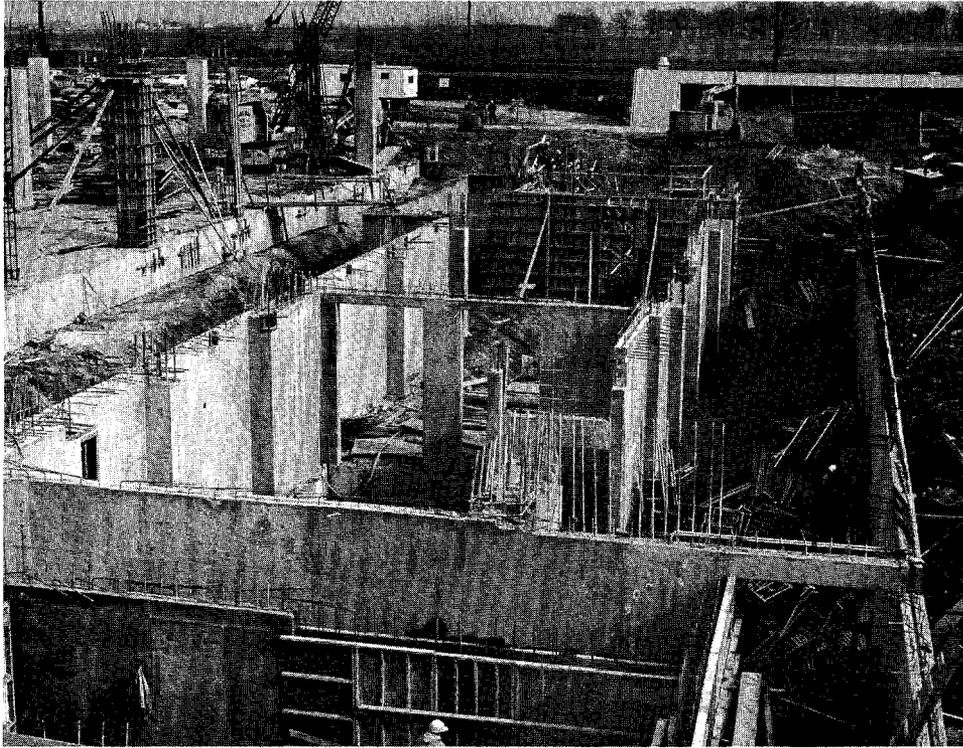
Fig. 10. Work on the Central Laboratory. The basement is at the right, the ground floor at the left. The Transfer Gallery and Main Ring are beyond.

4. Central Laboratory. Basement work has been completed, except for the floor slab, and all interior columns of the first phase are completed. The work on this first phase is shown in Fig. 10 and is 48% complete.
5. Industrial Building. The roof and siding have been completed and the contractor is thawing the ground inside in order to place the floor slab.
6. New Contracts. Notice to proceed has been issued to the Geo. D. Hardin Co. for utility-distribution systems in the experimental areas. The value of this contract is \$274,000. Notice to proceed has been issued to the Miller-Davis Co. for the third phase of the Neutrino Laboratory. The engineering
