MONTHLY REPORT OF ACTIVITIES

June 31, 1971

Abstract: This report summarizes the activities of the National Accelerator Laboratory in June, 1971.

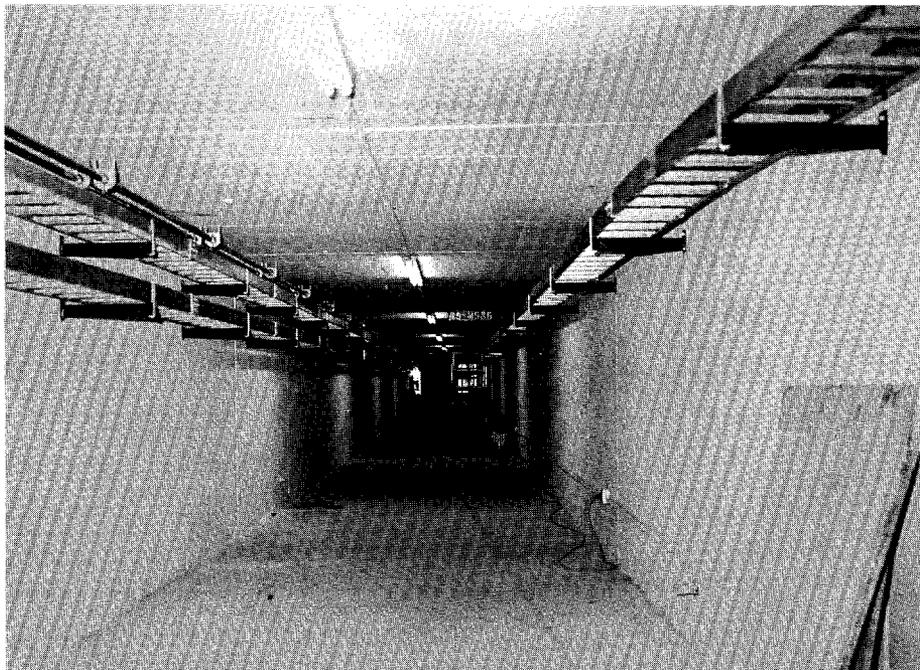
Fig. 3. Interior of a Meson Laboratory beam tunnel.

occupied by the Laboratory for component installation. Figure 3 shows the interior of the beam tunnel, and Fig. 4 is an aerial view of the entire Meson Laboratory.

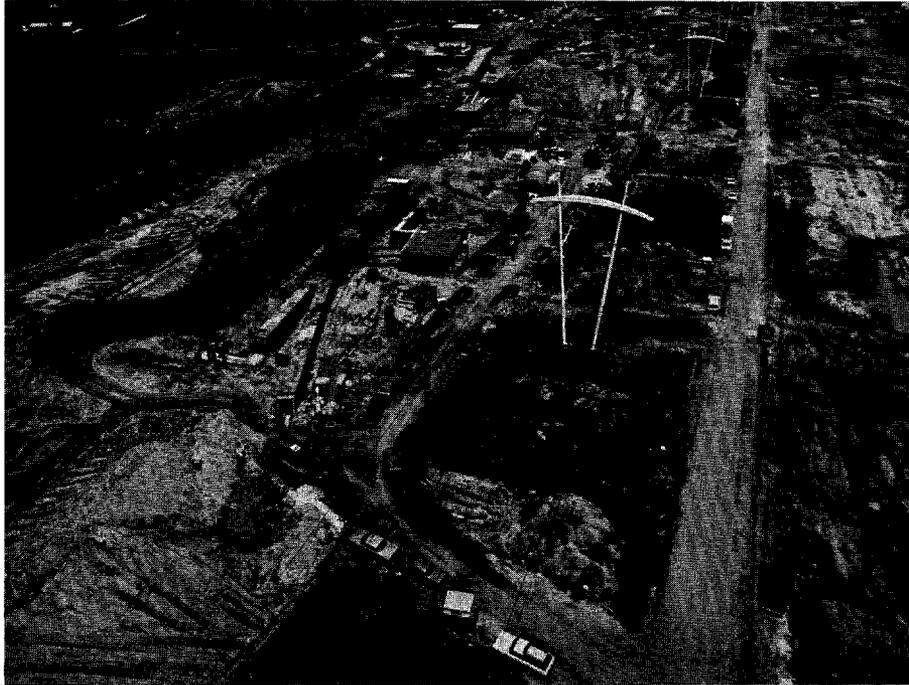
Fig. 4. The Meson Laboratory from the air. The target area is at the left.

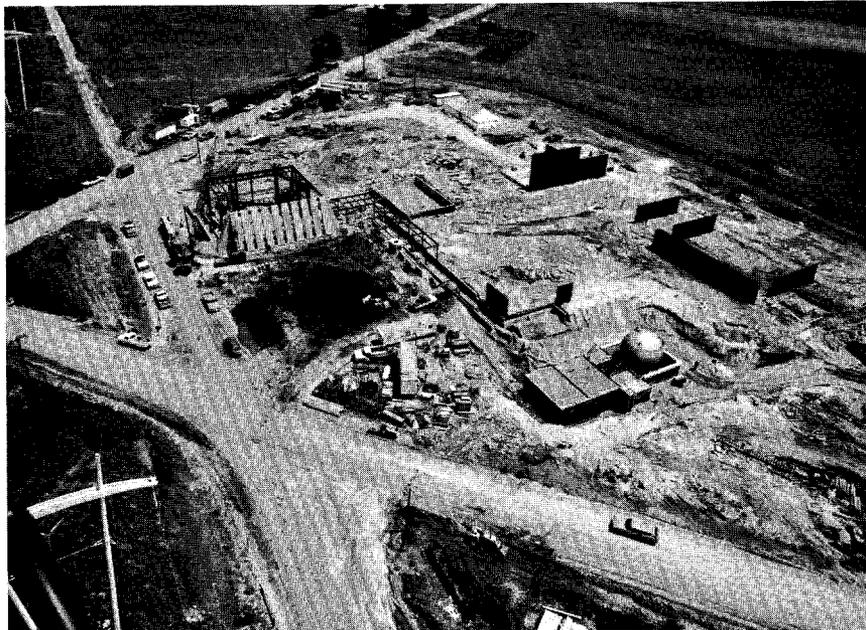
Fig. 6. The Neutrino Laboratory. The building with sloping walls is Building A, the Assembly Building. The bubble-chamber vacuum tank can be seen in the foundation of Building B, the Bubble-Chamber building. Above it are Building C, the Counter Building, and Building D, the 30-inch Chamber Building.

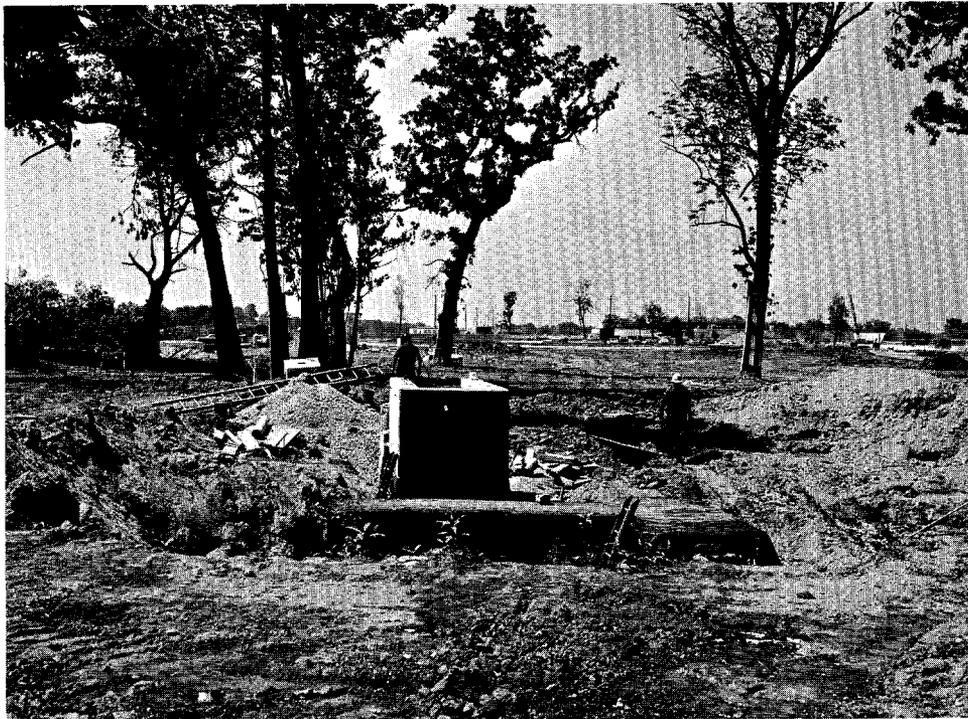
Fig. 8. Looking back along the beam line toward the Injection Area. In the foreground is an access hatch. Beyond the trees, the excavation is completely filled. Just visible through the trees is the access house above the beam dump.

3. Proton Switchyard. The contract is 95% complete. The beam dump is covered, as can be seen in Fig. 8.

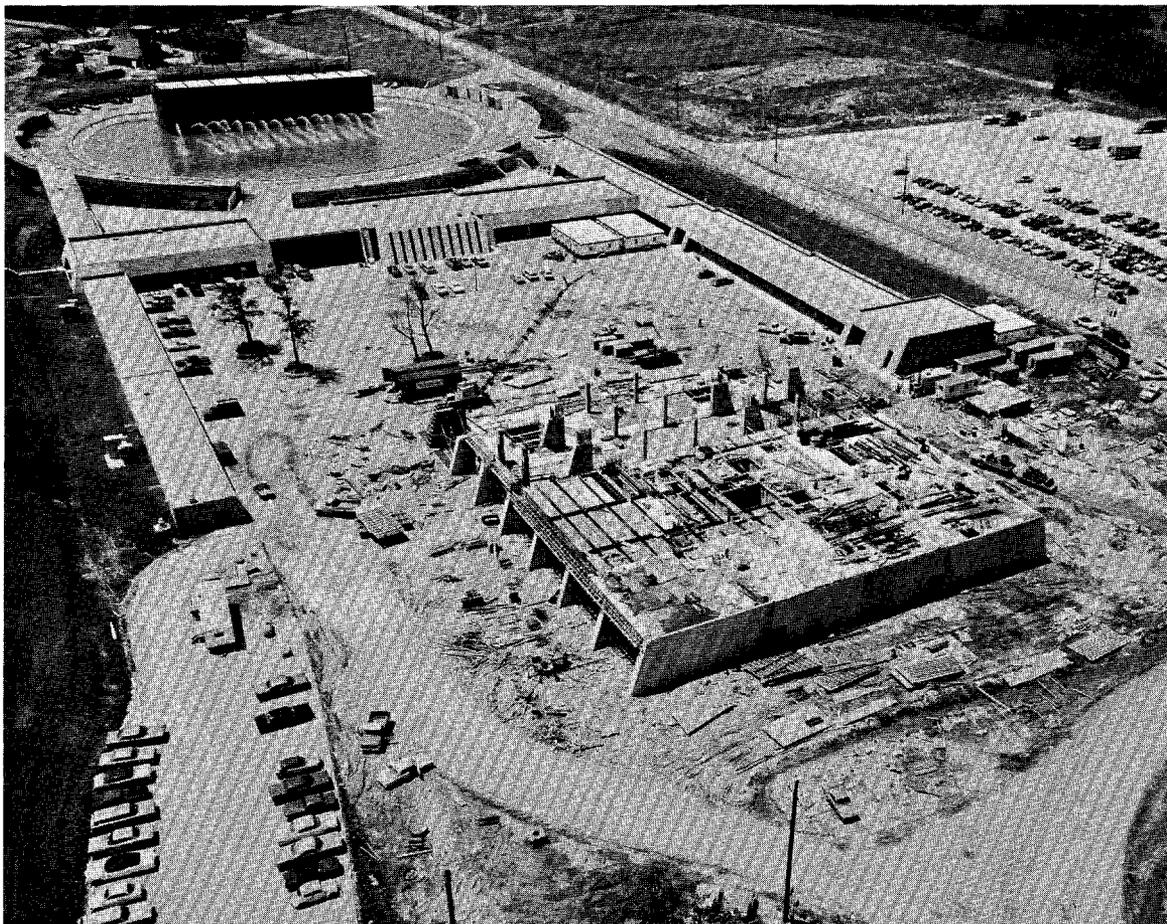
Fig. 9. A recent aerial view of the Injection Area. The Central Laboratory is in the foreground. The water sprays in the Booster pond are part of the accelerator cooling system.

Figure 9 is an aerial view of the Injection Area.
